DATE: November 27, 2000
TO: All Dealers
FROM: Customer Service Group
SUBJECT: ArvinMeritor NHTSA Recall

CUSTOMER SERVICE BULLETIN 00-19

Service Bulletin #LNK-112

EDL Socket Replacement (Tie Rods)

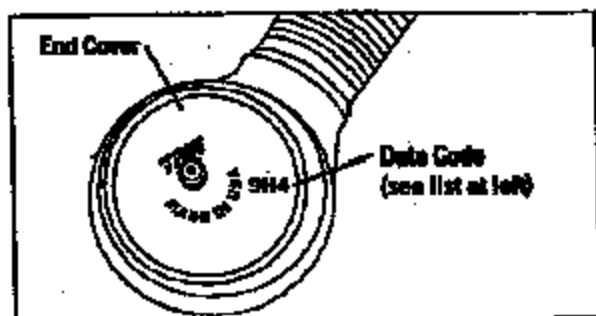
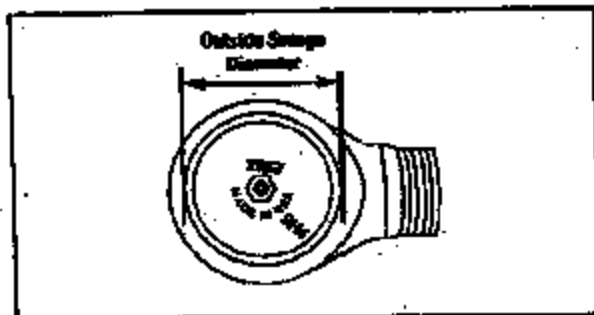
AND _____ The sockets are "20 size" sockets. To identify the size: Measure the outside swage diameter. A 20 size socket will measure approx. 1 7/8". Any socket measuring 2 1/8" is a "24 size" socket, and is not part of the campaign.

NOTE: Only 20 size sockets are subject to this campaign. Make sure you are servicing the correct size socket.

NOTE: Any socket with "DL" stamped into the end cover is a different design, and IS NOT part of this campaign.

THEN _____ Both socket ends need to be replaced using this kit.
